Urban Stream Restoration Protects Access Road

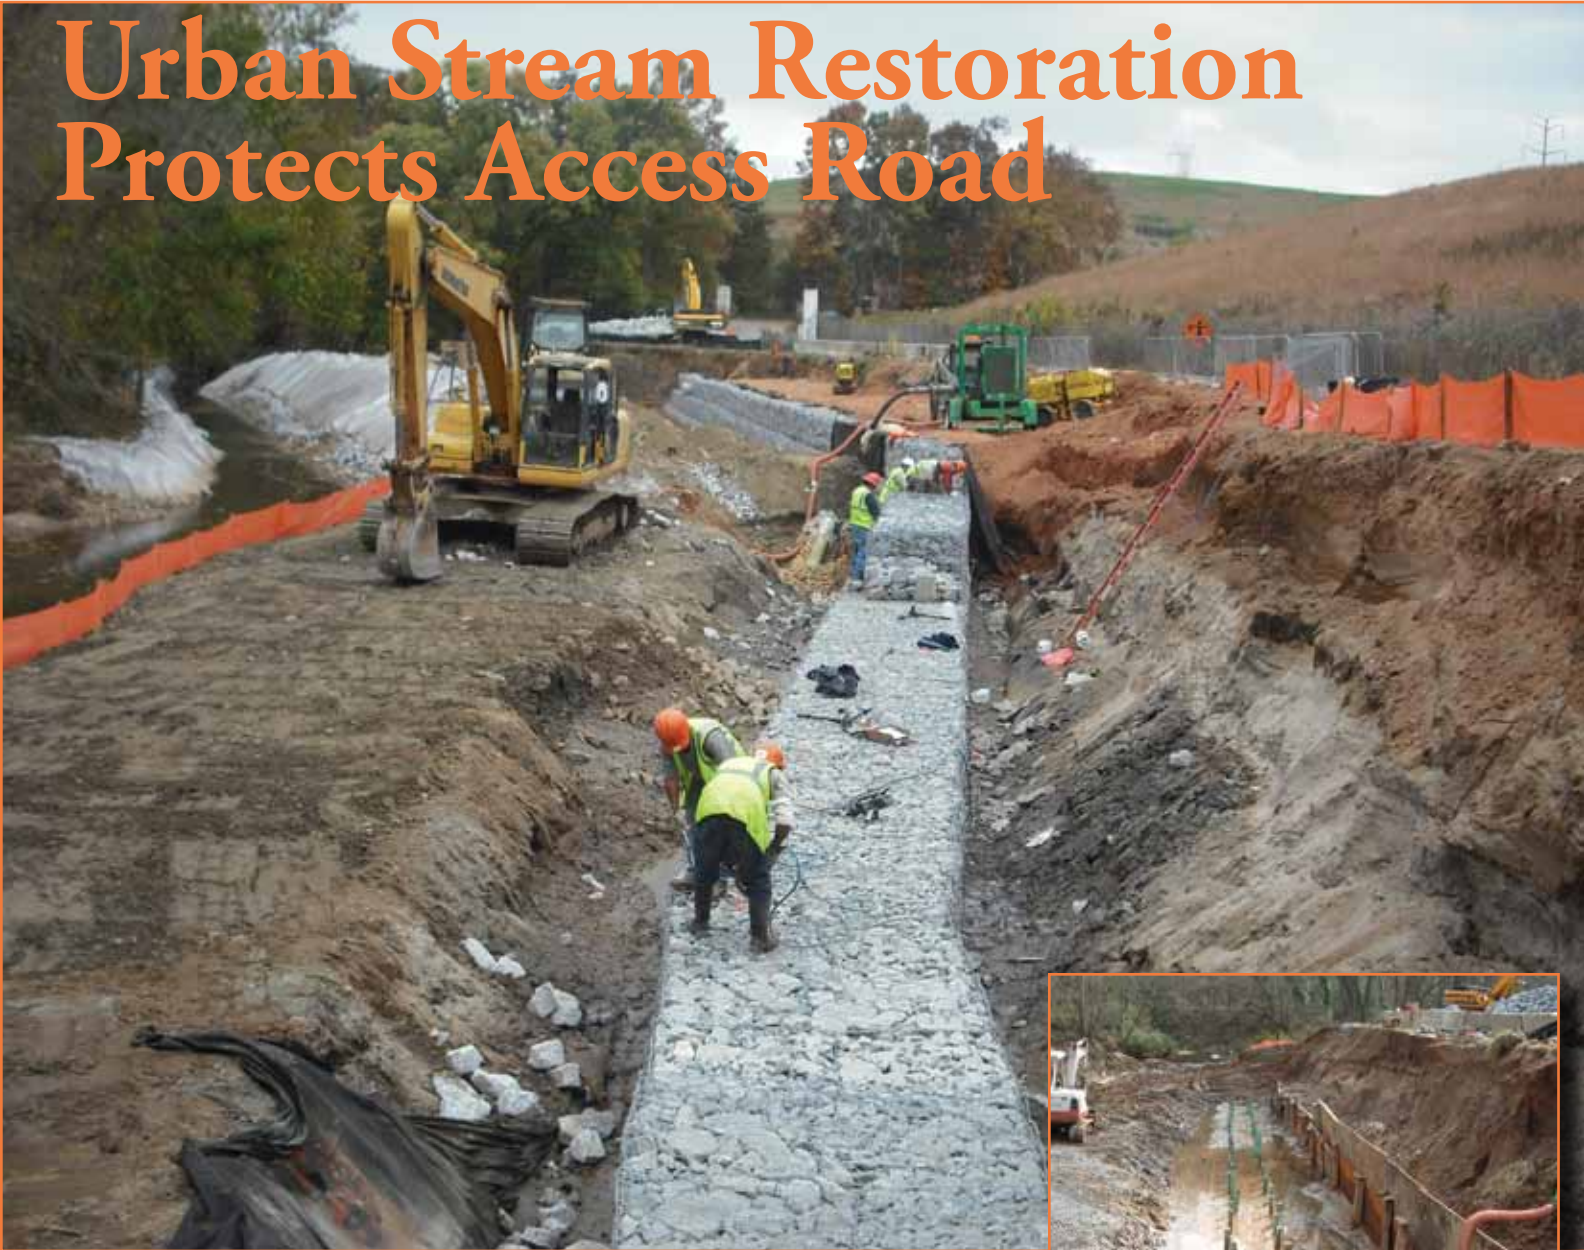
Workers install gabion baskets (above). Concrete foundation poured and ready for gabion basket installation (inset).

Once stream flow had been transferred to the temporary by-pass channel, construction on the main Maccaferri gabion wall began. The design plans had called for rebar to be drilled and grouted into the bedrock below the gabion wall. Upon excavation no bedrock was found up to 10 feet below the existing stream bottom. The soils report, which showed bedrock 1 to 2 feet under the stream, had been incorrect or misinterpreted with the design work. To ensure the stability of the gabion wall without a connection to bedrock, the design firm CH2M Hill reworked the requirements and requested a concrete footing with a solid interface to the gabion wall. Eventually an 18-inch concrete footing was poured below the

lowest gabion and steel reinforced bollards were extended to coincide with the middle of each 6x3x3 gabion basket. It was critical to construct the gabion wall as quickly as possible to secure the roadway. Intrinchment Creek epitomizes urban stream flow where rapid flow increases occur following any substantial storm events. The typical flow along Intrinchment Creek is around 7 CFS and at the work site this equated to a water depth of around 1 - 2 feet. During one severe storm event over 2 inches of rain fell across Atlanta in a few hours and the worksite water levels rose to over 10 feet in about that same amount of time. It was difficult at first to anticipate the amount of power and erosion that these flows are capable of when looking at the stream during normal flow conditions.

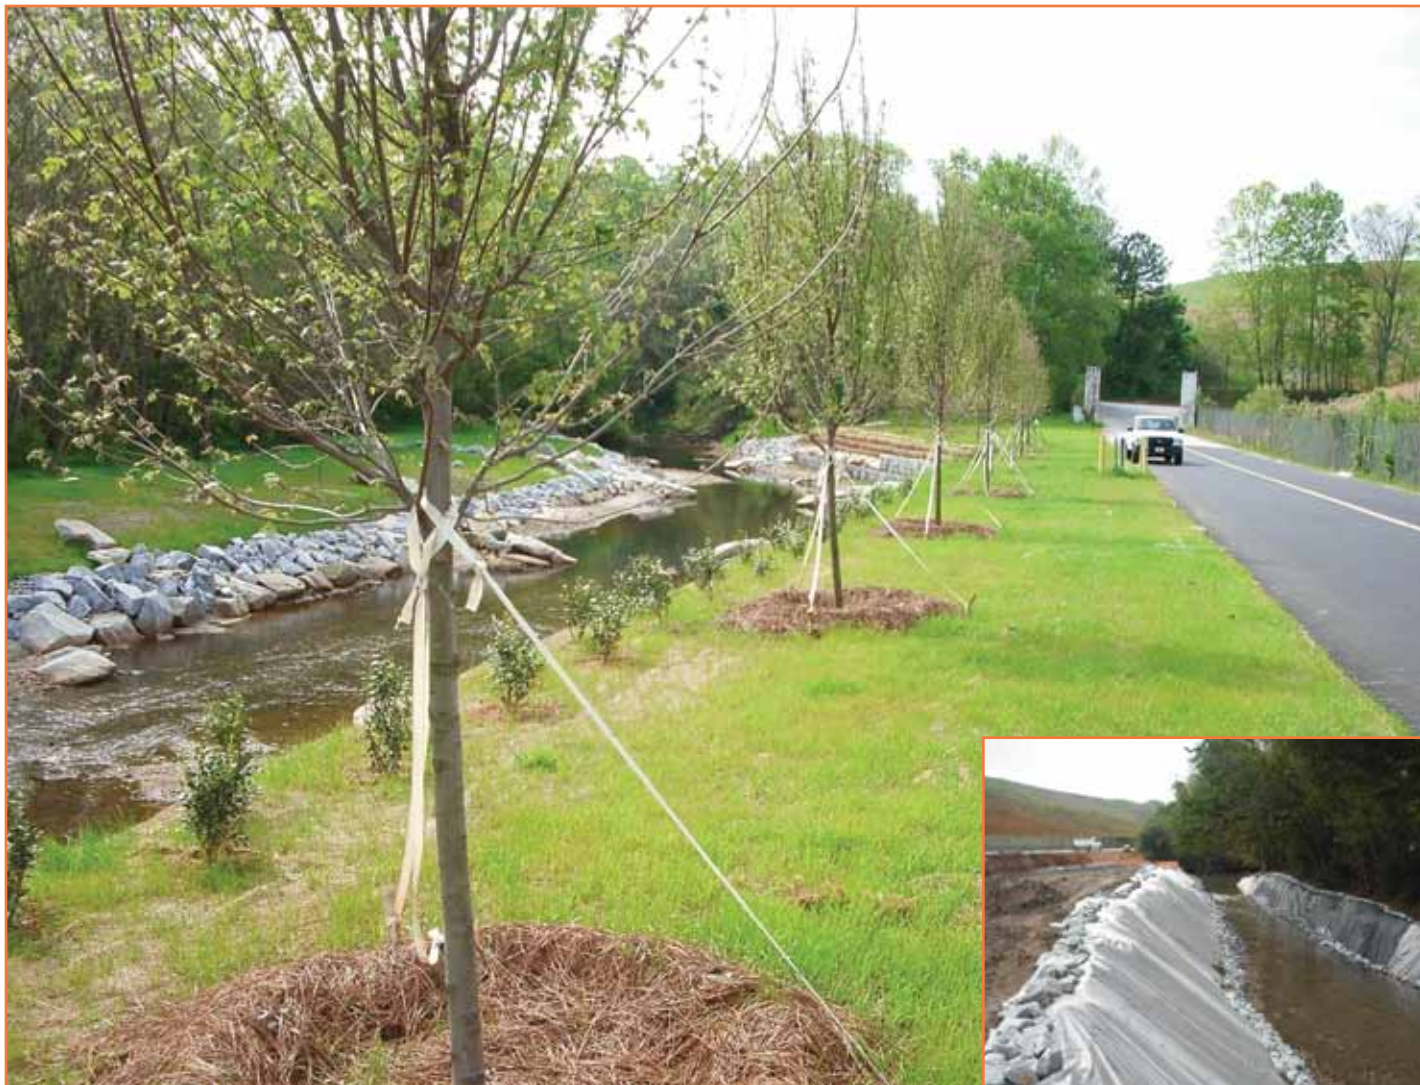
View looking upstream to downstream of completed project (above). Temporary by-pass channel (inset).
